NASA (TECHNICAL NOTE)

NASA TN D-3512

**HYPERVELOCITY IMPACTS INTO STAINLESS-STEEL TUBES
ARMORED WITH REINFORCED BERYLLIUM**

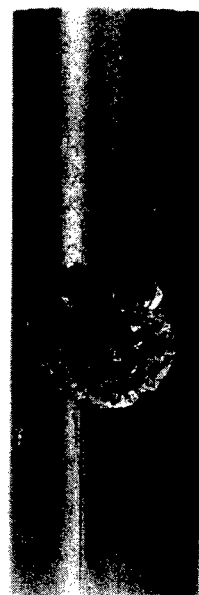
Comparisons. - Figure 8 shows a comparison of the unreinforced-beryllium-armored tube from reference 4 and the reinforced-beryllium-armored tubes tested in this investigation. As indicated previously, all targets were comparable in dimen-

Figure 8. - Comparison of impact damage on tubes armored with unreinforced and reinforced beryllium. Nominal impact conditions: projectile, 3/32-inch-diameter Pyrex sphere; impact velocity, 24 000 feet per second; target temperature, 1300° F.

sions and were tested under nominally the same impact conditions. Hence, direct qualitative comparisons can be made.

A front-surface spalled area and radial cracks appeared on the target shown in figure 7. The compartmented design, however, had the most extensive armor loss and cracking damage in comparison with the unreinforced armor. The mesh and fiber reinforcements did not significantly reduce or limit the external cracking damage. Each of the four armor configurations prevented the 3/32-inch-diameter Pyrex sphere from perforating the internal liner, and all the targets were dimpled on the inner surface of the tube under the point of impact.

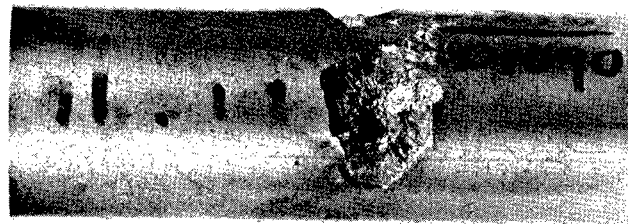
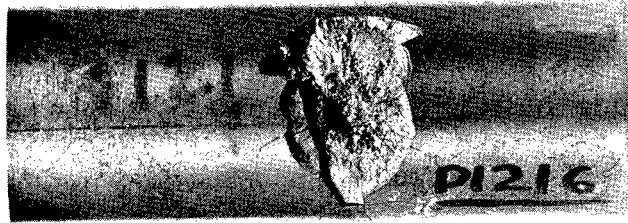
Double impact. - A fiber-reinforced target was impacted twice to determine if repeated impacts would result in removal of large segments of the armor cracked by the first impact. On the particular target tested, the second impact was made approximately 90° from the first impact in the same plane. Figure 9 shows both impacts and the condition of the armor between the craters. Large segments of the armor were not lost, and the increase in cracking damage was not appreciable. The cracked area around the second crater was slightly larger than that around the first crater, as can be seen from a

Figure 9. - Fiber-reinforced beryllium armored tube after two impacts. Test conditions (each impact): 3/32-inch Pyrex sphere; nominal impact velocity, 24 000 feet per second; target temperature, 1300 F.

comparison with figure 8. Neither of the impacts, however, perforated the liner tube, and only internal dimples were visible on the inside surface of the tube.

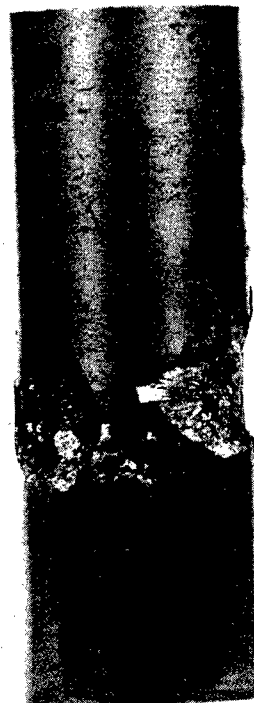
Figure 10. - Unreinforced and fiber-reinforced beryllium tubes after two impacts. Test conditions: 3/32-inch-diameter Pyrex sphere; nominal impact velocity, 24 000 feet per second; target temperature, 1300° F.

Figure 10 shows a comparison of an unreinforced-beryllium-armored tube (ref. 4) after two impacts and target 4 of this investigation. As shown in table I (p. 6), the unreinforced target was impacted at approximately the same velocity but at a greater impact angle. Also, the wall thickness of the liner tube for the unreinforced target was 0.010 inch thick, while all targets tested in this investigation had 0.028-inch-thick liners; however, the gross damage aspects of the two targets can be compared.

Neither the fiber-reinforced nor the unreinforced targets lost armor from the combined effect of the two impacts. The liner tubes were not perforated on either of the targets, and only dimples appeared on the inner surface of the liner under the

points of impact. A crack connecting the two craters was observed on both of the targets.
